Transport
Canada

TP 6980E

Issue 4/2005

Canadian Aviation Service Difficulty Reports

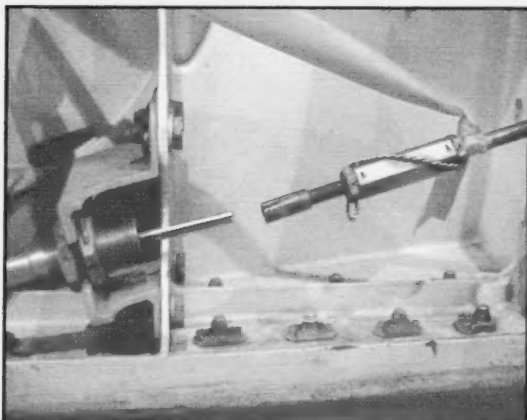
SDR # 20051012006

Auto-throttle Cable Severed

When both engines were removed for inspection access during a heavy maintenance visit, the left engine auto-throttle retard cable was found severed. (Canadair IPC, Chapter 76-10-00, Figure 2, Item 220).

The cable was cleanly severed between the drilled jam nut (Item 125), and nut (Item 165), just aft of the bellcrank (Item 85).

In this case, an astute technician found this defective cable. The OEM is currently investigating the cause of the cable breakage.

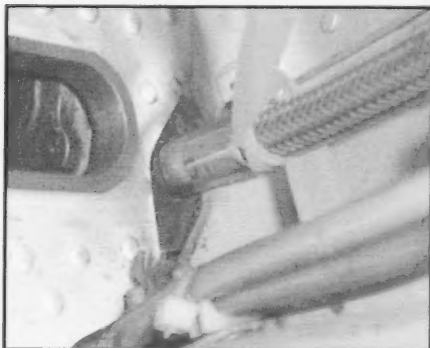
Flap Flex Shaft Retainer Missing

While performing a visual inspection, the right flap flex shaft retainer was discovered to be missing and possibly broken off.

These retainers are sometimes difficult to inspect as they are often covered with dirt or grease.

AMEs are reminded to take the time to inspect for these devices that are installed on many different aircraft. ✖

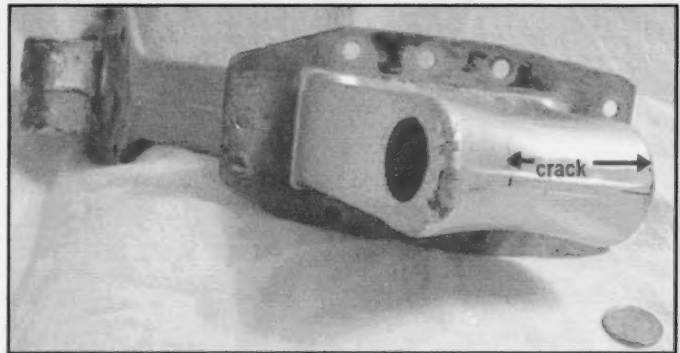
Float Strut Attachment Fitting Cracked

Upon removal of the spreader bar from the float, a crack was noted along the casting seam of the right front float strut fitting. The only time this area is exposed is during heavy maintenance, when the aircraft is removed from floats and the floats are dismantled.

While sourcing replacement parts for the repair, an overhaul facility stated that they have come across six (6) castings within the last couple of years with similar cracking along the casting seam at the taper pin attaching point.

In this particular incident, the float assembly was an EDO 679-4930 float made under licence by Bristol aircraft. The cracked fittings in question are not being inspected at scheduled intervals because it requires removal and disassembly of the float. Age seems to have been a major factor in the cracking of the fittings found so far. The associated image shows that the crack had progressed to approximately 75% of the fitting and failure was inevitable. ✖

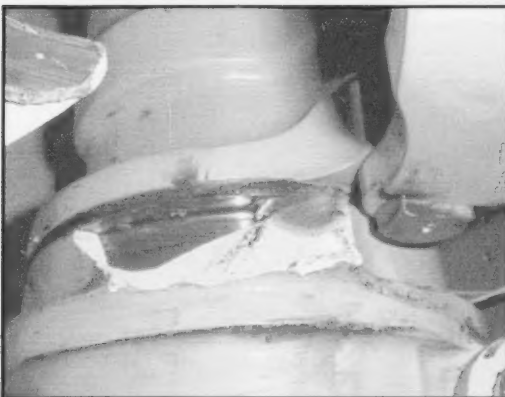
SDR # 20050408003

Nose Wheel Steering Collar Fractured

Following aircraft arrival, the crew reported steering problems. Investigation by maintenance personnel revealed that the nose wheel steering collar had completely fractured. Fortunately, no secondary damage was caused by this event.

The responsible overhaul facility stated that fractures of this nature are caused by repetitive and excessive turning inputs. The aluminum collar, especially at the pivot point, is not designed to withstand the severe stresses imposed during sharp turns.

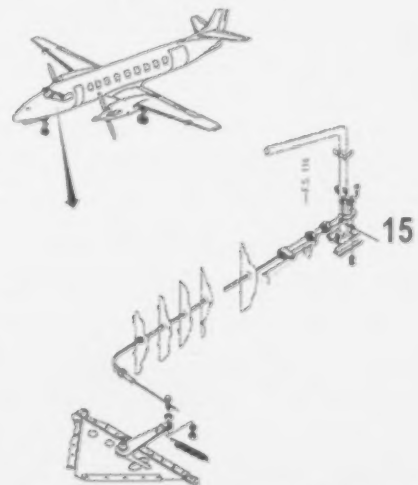
Emergency Extension Release Cable/Bellcrank

When complying with an unrelated inspection under the cockpit floor, maintenance discovered the nose landing gear emergency release cable was sheared at the clevis where it attaches to the handle bell crank. The cable failed at the point where it attaches to IPC 32-30-00, Fig 4, Item 15.

This aircraft had recently (within 50 hours) undergone a phase 5 inspection where the system was inspected and tested, and no defects were found. The cable was replaced with a serviceable unit, gear swings were conducted and no further faults found.

This is the first failure of this type experienced by this operator. ✖

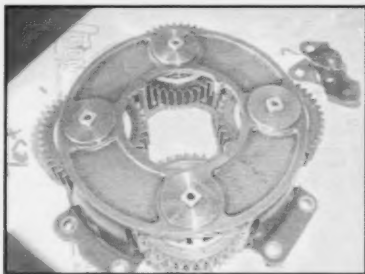
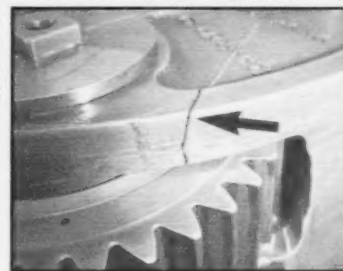
Planetary Gear Carrier Cracked

The flight crew observed the engine oil pressure trend to be steadily declining over a short period of time. As an experienced operator of this engine, it was thought that this indicated a cracking problem with the planetary gear carrier in the engine gearbox. The engine was removed and, as suspected, the planetary gear carrier assembly had multiple cracks and was near complete failure.

In a more recent SDR from the same operator that reported similar oil pressure problems resulting in another premature engine removal, the planetary gear carrier had fractured with pieces of the oil distribution galleries missing. Excessive wear was also evident on the planetary gears. During the last overhaul at only 381 hours ago, the LPI inspection revealed no cracks of this planetary gear carrier.

In addition, another SDR reported declining oil pressure that would drop even further on application of a higher power setting. Maintenance personnel changed various oil pressure regulating components in an unsuccessful attempt to rectify this snag. Eventually, the reduction gear case was disassembled and it was noted that the planetary gear carrier was completely cracked around its circumference. The oil galleries were affected by these cracks and caused the low oil pressure condition. The operator stated that an inadvertent or unreported over-torque event of the engine may have led to this problem. Complete failure would have caused severe damage to the engine and possibly caused a severe engine overspeed.

A service history review has revealed several other SDRs reporting declining oil pressure and cracked planetary gear carriers, P/N 8679225.

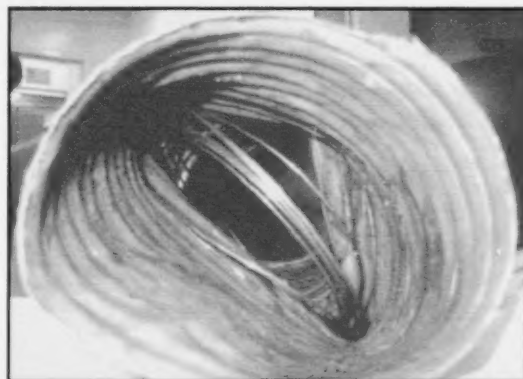
During post-flight inspection, the carburetor air intake duct metal reinforcement was found to be partially uncoiled.

It appears that atmospheric moisture may have formed into ice and then built up on the metal coils in the intake duct. Application of carburetor heat then dissolved the ice, thereby restoring engine power. ✖

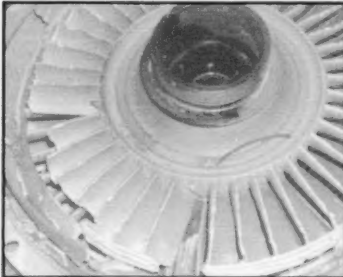
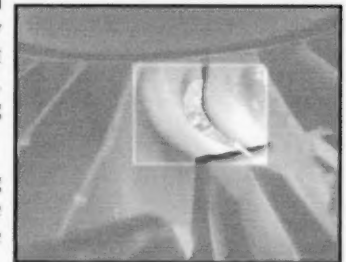
Turbine Wheel Liberated

During a scheduled landing with the weight of the rotorcraft on its wheels, the pilot heard a loud bang, followed by N2 deceleration of the right engine. An engine chip light indication was also noted at this time. Preliminary investigation revealed failure of the 3rd stage turbine wheel.

A domestic engine AMO investigation concluded that the 3rd stage turbine wheel was the primary failed item. It appears that cracks developed at the trailing edges of the blade root end, eventually resulting with the blade separating from the disc.

A review of the SDR data base revealed two other recent SDRs on this part number turbine wheel. One of these events occurred during flight resulting in a crash. The turbine wheels had only 1144 and 2852 hours since new (TSN), respectively.

Rolls Royce has issued CEB A-72-3068 requiring fluorescent penetrant inspection of all 3rd stage wheels at the next shop visit. No cracks are allowed in the hub or root end area of the blades.

It is therefore recommended that all operators comply with CEB A-72-3068. ✖

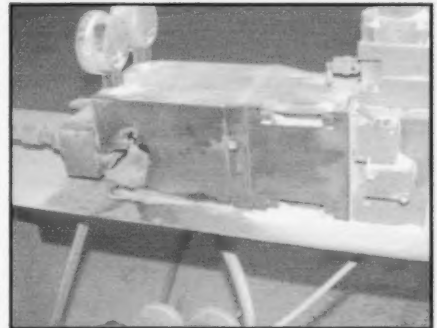
Fortunately, the ground operator of the subject oxygen booster unit escaped with minor burns. Quick action on the part of the nearby crew was instrumental in limiting any further damage.

Shop-powered hangar air (80 psi) is used to power this OB-30 portable oxygen booster unit to produce 2200 psi oxygen pressure.

The manufacturer did not positively identify the cause of this explosion, however, it is possible that contaminated shop air may have somehow seeped past the twin rod seals of the booster unit and caused this explosion. ✖

The operator stated that another filter has now been installed in the hangar shop air line even though the OB-30 unit does have a integral filtration device.

Following this event, the manufacturer of this equipment has made several upgrade improvements including a blast shield. The manufacturer's Installation, Operating and Maintenance Manuals do list a number of safety features and warnings/cautions to persons operating this equipment. In particular, that all personnel receive proper training and that components used in the oxygen system or shop air system shall be clean, dry and free of all contamination.

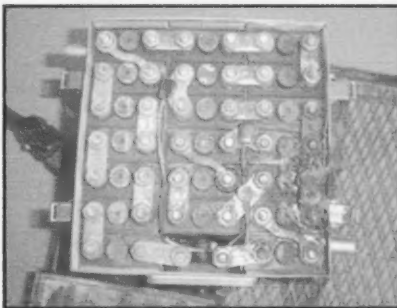
SDR # 20050624007

Ni-Cad Battery Damaged

During a scheduled check, the ni-cad battery was observed to have a 1-inch diameter hole in the top of the case. Erosion was also evident on the side of the battery case. Three cells in the area of this hole exhibited evidence of overheating and thermal damage.

This battery has (six) 6 months time in service since new and 226 hours since its last service.

It has not been determined what caused this damage, however thermal runaway is a possibility. Thermal runaway is a condition where the battery chemicals overheat to such a degree that the battery can be destroyed or even explode.

The nickel-cadmium battery requires specific maintenance procedures; always follow the manufacturer's recommendations. ✖

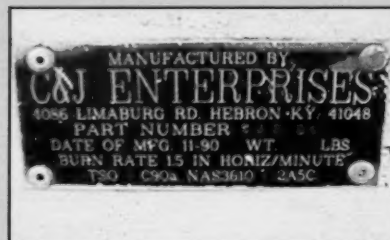
Figure 2. Authentic Data Tag

The falsified data tags identified the ULDs as manufactured by C&J Enterprises, 4086 Limaburg Road, Hebron, JY (rather than KY) 41048 and identified the part number as CJE (rather than CJE-90). Some tags also lacked the date of manufacture and burn rate information that TSO-C90 and NAS 3610 require to be displayed. (See Figures 1 and 2 for falsified and authentic data tags.)

Regulations require that type-certificated products conform to their type design. Aircraft owners, operators, maintenance organizations, and parts distributors should inspect their aircraft, aircraft records, and/or part inventories for fiberglass ULDs that have been sold by IDF, S.A. or distributed by Apparel Transportation, Inc. Referenced ULDs installed on aircraft should be inspected for conformity to type design. If any are found in existing stock, it is recommended that the ULD be quarantined to prevent installation until a determination can be made regarding each ULD's eligibility for installation.
